IMPACT OF FLOOD/ LANDSLIDES ON BIODIVERSITY

COMMUNITY PERSPECTIVES

KERALA STATE BIODIVERSITY BOARD

IMPACT OF FLOOD/LANDSLIDES ON BIODIVERSITY - COMMUNITY PERSPECTIVES

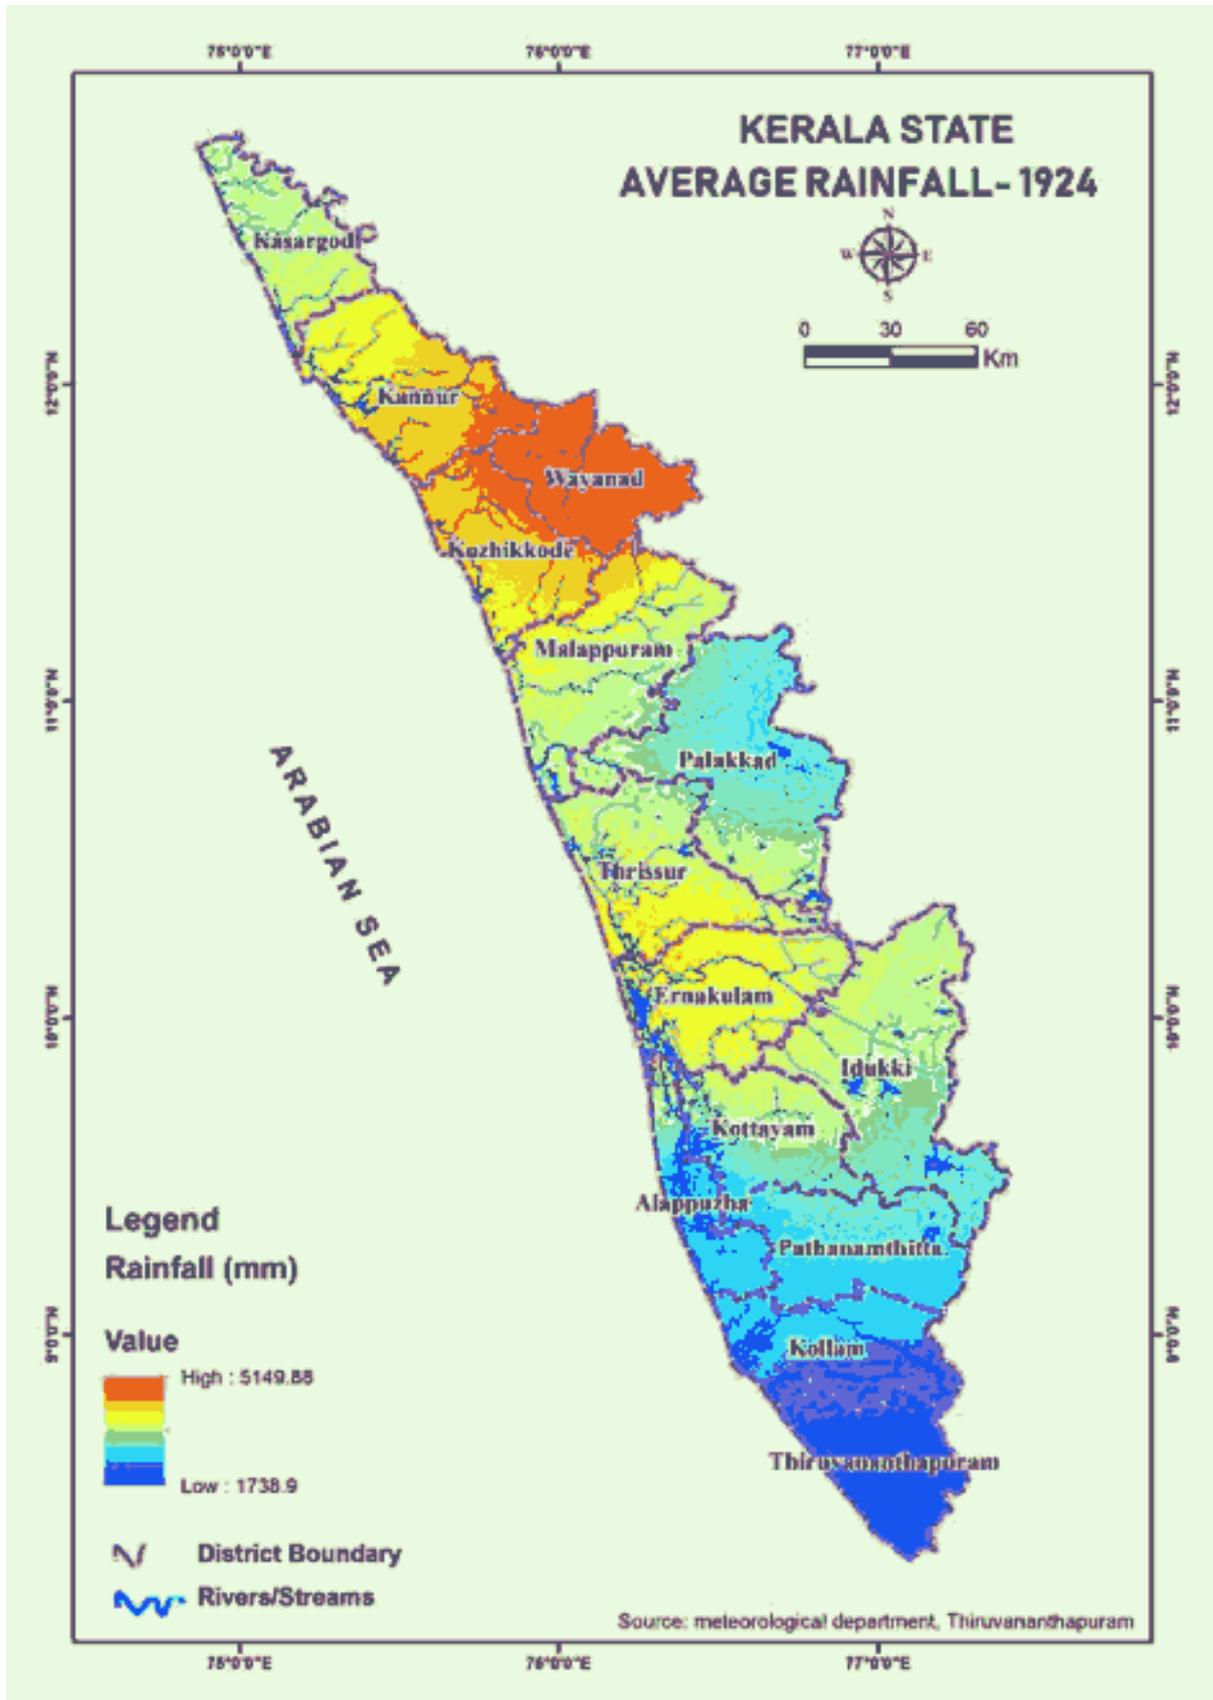
Fig.2. Average Rainfall -1924

Fig 1, 2 and 3 shows the Annual average rainfall in Kerala, during 2018 and during 1924. The figures clearly shows the difference in rainfall in two major affected districts Wayanad and Idukki. During 2018 Idukki recorded a rainfall an excess of 92 % rainfall when compared to normal season, where as in Wayanad it was only 24 % excess. Palakkad also observed an increase of 75 %. Still Wayanad was one of the worst affected in terms of landslide, and flood. In all the panchayats studied the general observation of the local people was that the impact was due to change in land use especially the construction activities in wetlands and the gradual change in nature of the marshy lands of Wayanad.

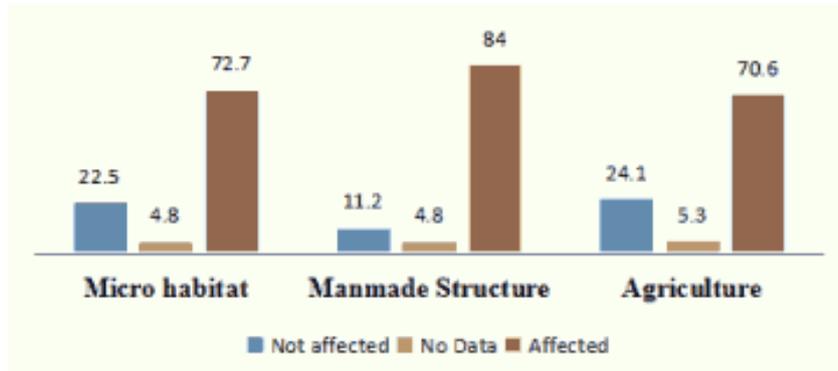
Fig.8 Damage to Microhabitat, Manmade Structures, Agriculture.

Agriculture, Microhabitats and Manmade structure were most severely affected. In riverine ecosystem sand deposition, silt deposition and soil erosion are the major impacts. In the case of pollution majority of the respondents identified solid waste as the major issue in 84 % of study areawhile industrial pollution is very minor at 29.9 % and is restricted to certain pockets of industrialized areas.

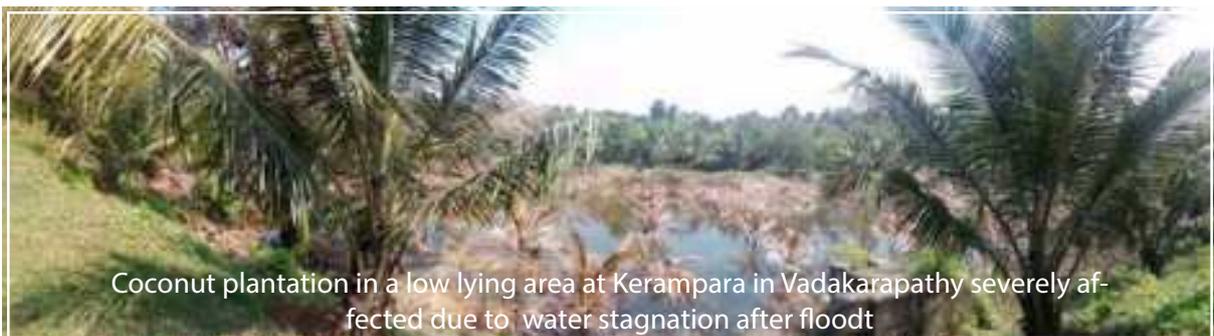
Gully formed in kerampara in Vadakarapathy consequent to breach of bund and flash flood causing complete loss of vegetation
